DRINKING WATER INSPECTORATE

DWI Ref: 2025/10706

DRINKING WATER QUALITY EVENT

Location: Tunbridge Wells, Kent
Nature: Loss of Supplies and Media Interest – (Pembury works)
Date of event: 29 November 2025

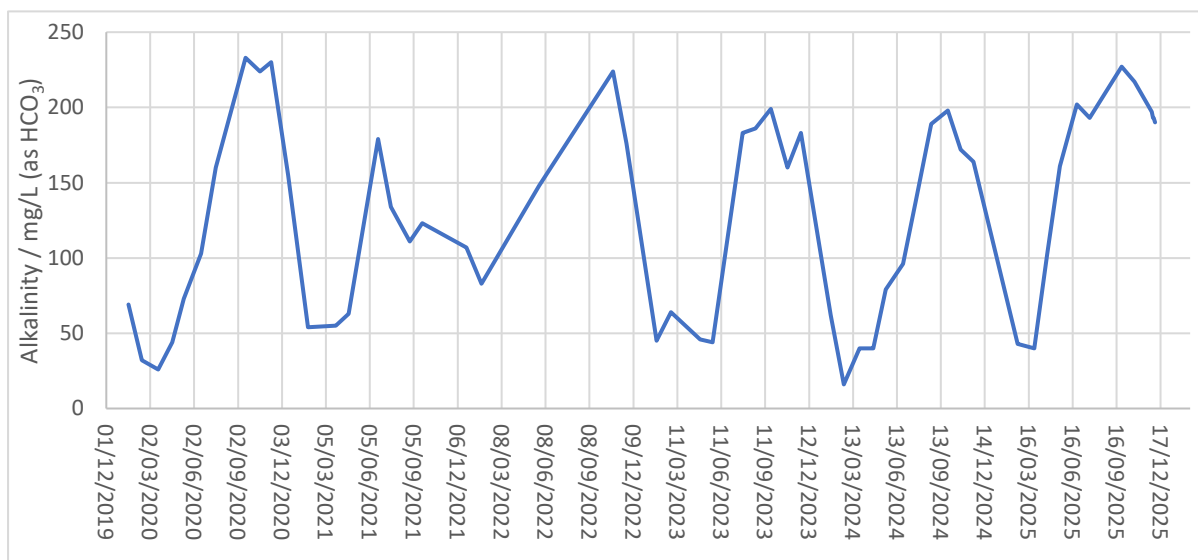
although the frequency of company sample data for alkalinity is sparse at times. Alkalinity leading up to the event appears to have been relatively stable and above 200 mg/L since June and peaking at ~225 mg/L in September. It was on a slow, steady decline at the time of the event at approximately 200 mg/L HCO₃; at no point leading up to or during the event did alkalinity reach a historic high, nor was there any rapid change.

Figure 1: Raw alkalinity at Pembury works, 2020-25

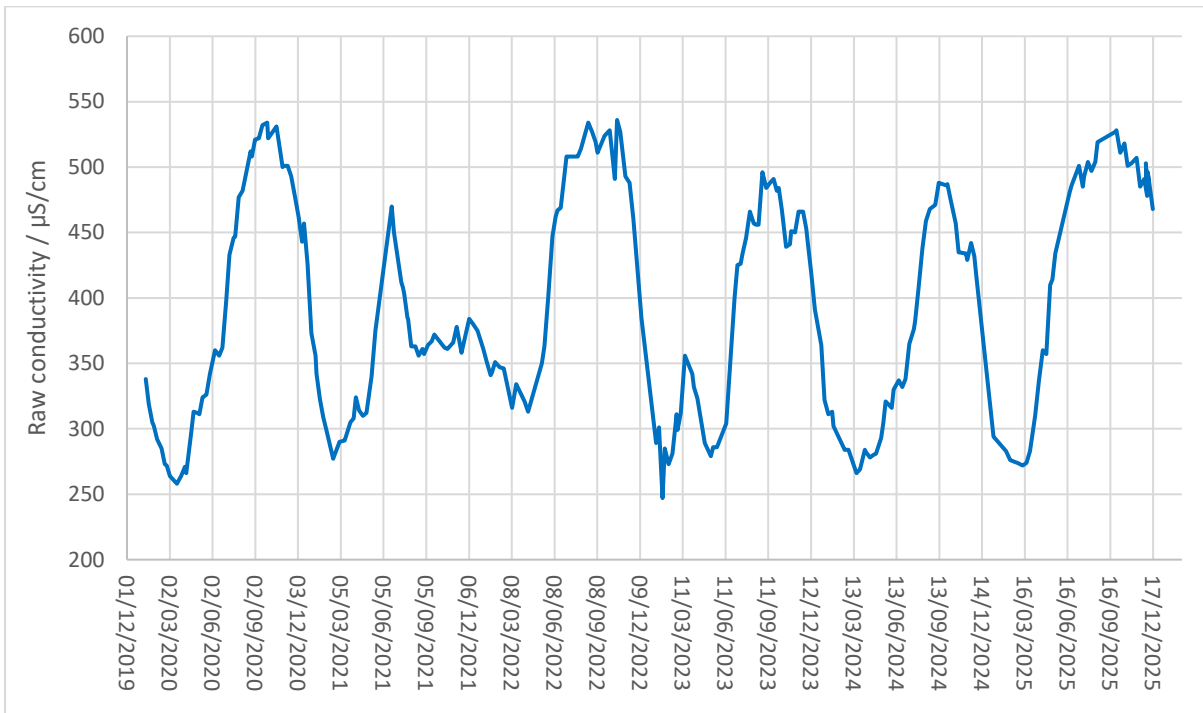
3.2.3 The raw water electrical conductivity (EC) can be seen to be similar to alkalinity (which is expected given alkalinity contributes to EC), with a broad seasonal autumnal peak observed as in previous years reaching a maximum of around 530 µS/cm in mid-September 2025. This was a little higher than 2023 or 2024 (470-490 µS/cm), but almost exactly matching the patterns, dates and peak concentrations of 2020 and 2022. In the weeks leading up to the event in late November 2025, the conductivity had remained between 480 and 510 µS/cm and was in gradual decline in line with previous years' seasonal peaks. At no stage leading up to or during the event did this parameter rapidly or suddenly shift beyond established patterns.

Figure 2: Raw EC at Pembury works, 2020-25

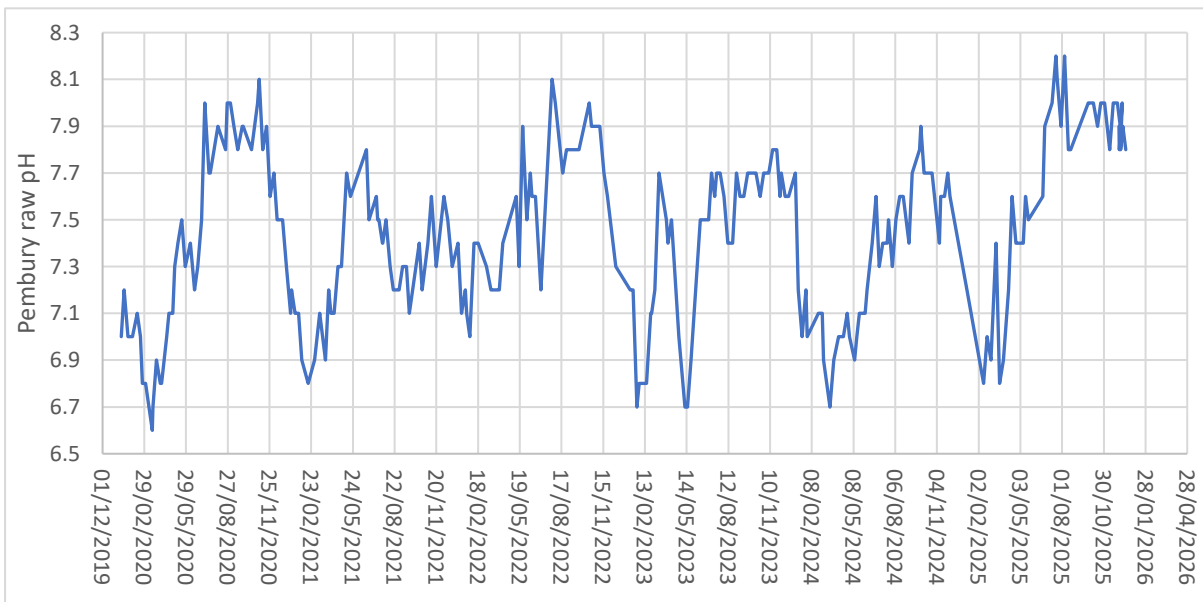
3.2.4 Raw pH was approximately 8 at the time of the event, making it relatively high for the site but it had been between 7.8 and 8.2 since June 2025 and had been around this level for significant parts of 2020 and 2022 seemingly without consequence.

Figure 3: Raw pH at Pembury works 2020-2025

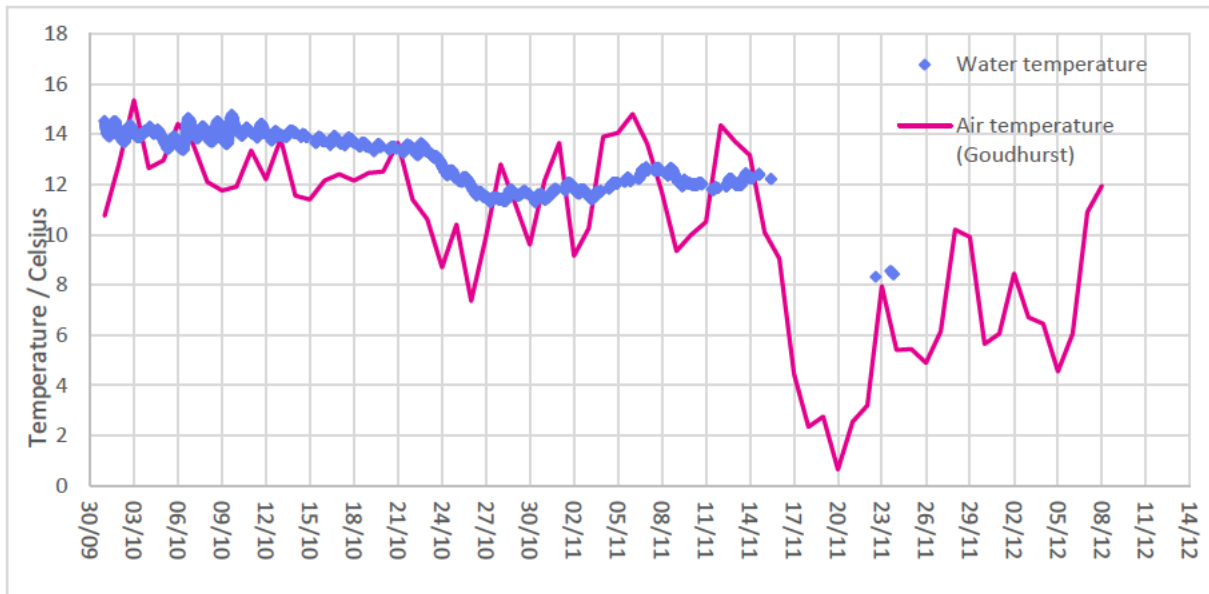
3.2.5 Water temperature is not monitored at the inlet to Pembury works, although a floating monitor in the reservoir, referred to as the ‘algae star’, has some water temperature monitoring that can be manually downloaded. Data was downloaded after the event and so the data was unavailable to inform

operational decisions or potential mitigative actions in the lead up to or during the event. The 'algae star' ceased recording temperature data on 15 November 2025 due to an unknown fault and briefly recorded again on 23 November before failing again. The limited raw water temperature data available (shown in Figure 1 below) indicates a drop to around 8.5°C on the 23 November having dropped from 12.2°C on the 15 November, corresponding to a cold snap recorded in air temperature between 16 and 21 November. Given the rapidly recovering air temperatures after 21 November, it is likely that the water temperature leading up to and during the event was around 8-9°C although this number is extrapolative and cannot be proven definitively.

Figure 4: 2025 data for water temperature (from the 'algae star') and air temperature (from the nearby Goudhurst weather station -source Met Office), November-December 2025

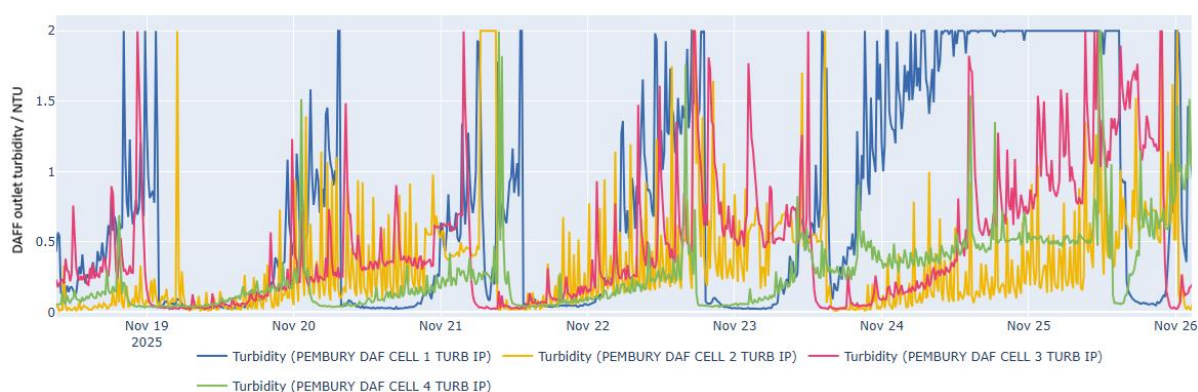
3.4.4 From approximately 19 November, the situation worsened from individual DAFF vessels showing signs of difficulty (higher turbidity, worsening baseline and shorter run times) to all four vessels showing continuous signs of progressive deterioration in running and cleaning performance for approximately the following week.

Figure 5: Pembury DAFF outlet turbidities, approximately November 18-26 2025

- 3.4.5 There does not appear to have been adequate recognition of this onsite, with the site log noting that DAFF 3 failed to wash on 21 and 23 November due to insufficient drain down in the allotted time, being reset manually and washed again. Failure to drain down the vessel would be indicative of the filter becoming blocked. There appears to have been two work orders raised at 15:01 and 15:02 on 22 November regarding 'ALARM LEVEL: 5 - PEMBURY DAF FILTER NO2 TURBIDITY VERY HIGH' although from the information provided and collated from site there does not appear to have been any specific follow up to this action. Another log entry on 25 November noted the DAFF outlet turbidity was high and that DAFF 1 and DAFF 4 had both failed to wash for 60 and 64 hours, respectively. This failure was attributed by staff onsite to a sludge blockage in the site's dirty washwater tank keeping that tank full and preventing washing. It can be extrapolated from the failed-wash times specified and the site online process trends that these observations were made around 08:30 to 09:00 on 25 November. By this stage, DAFF 1's outlet turbidity had been continuously above 1 NTU for around 36 hours and off-scale (>2 NTU) for around 20 hours with no apparent corrective actions taken.

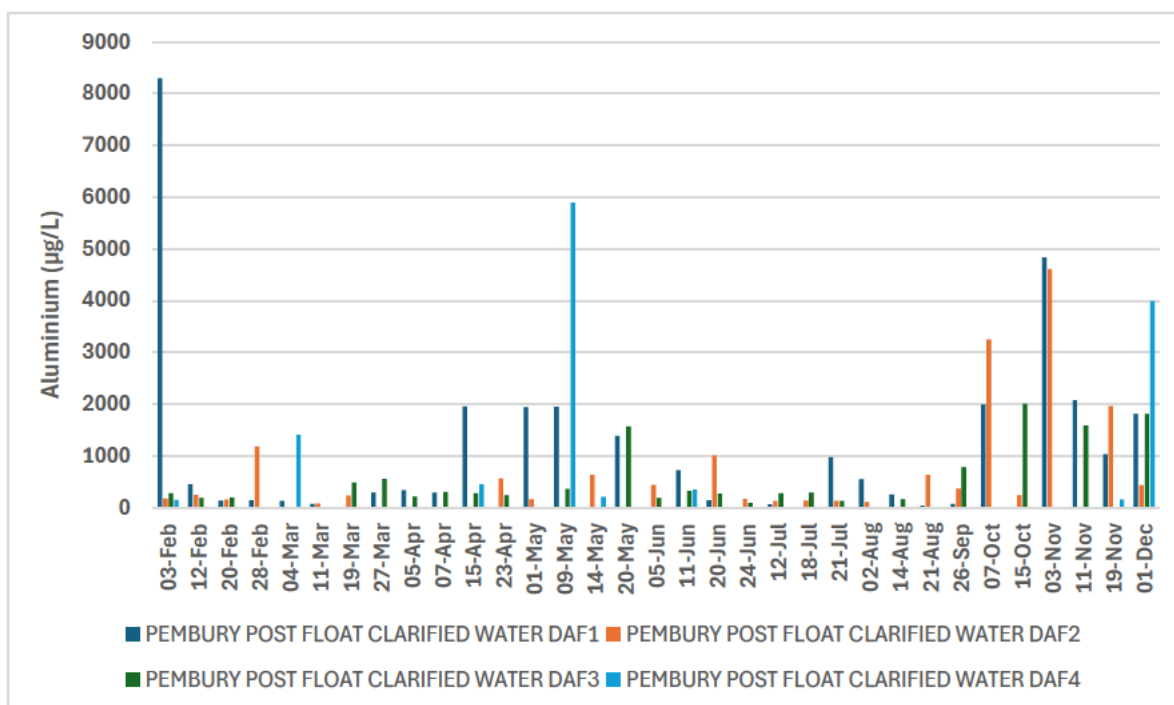
- 3.4.8 High aluminium levels are observed much more frequently for samples taken in October and November 2025, indicating a general deterioration in DAFF vessel performance (Figure 6 below).

Figure 6: Total aluminium, recorded in lab samples from the individual DAF units during 2025

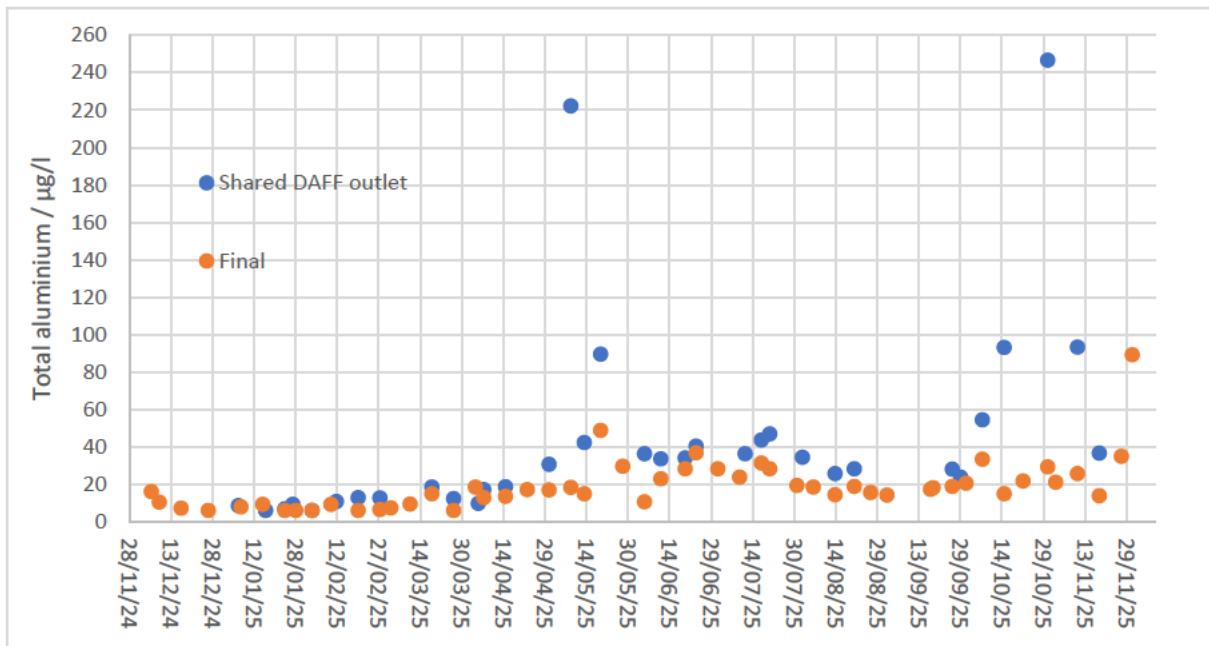
3.4.10 Operational laboratory samples are more frequent and consistent at a very approximately weekly schedule. A significant proportion of post-DAFF samples are at elevated levels, including a 23 April 2025 sample not pictured on the graph in Figure 7 that recorded 1481.1 µg/l of total aluminium and a noticeably elevated series of post-DAFF samples in the two months prior to the event.

Figure 7: Aluminium (total) concentrations from lab samples on the combined DAFF outlet and works final at Pembury, 2025

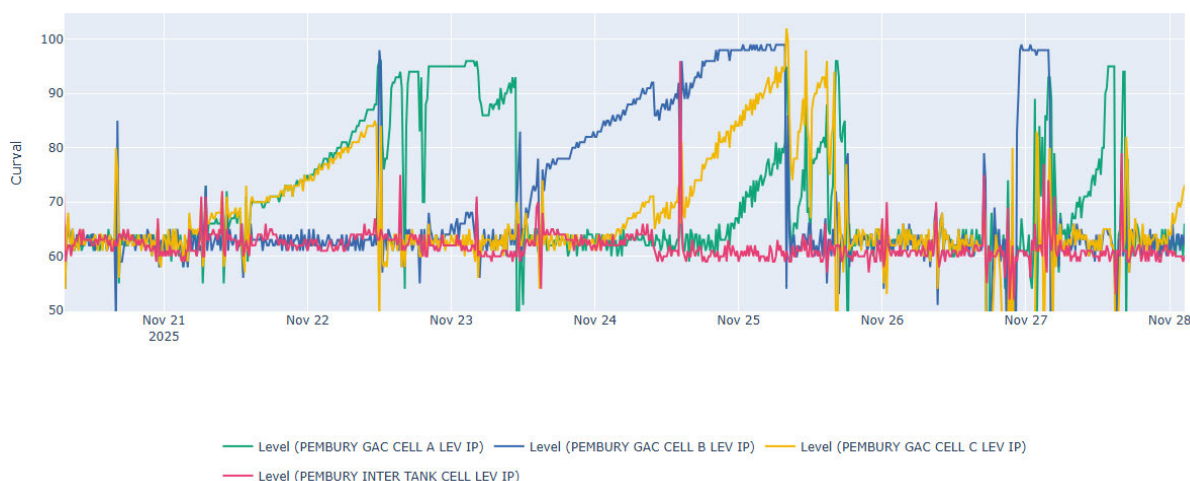
3.5.3 In a similar pattern to the progressive deterioration of all four DAFF vessels, the levels of GAC A and GAC C both started rising quickly from the early hours of 21 November 2025, with GAC A reaching 85% full when it washed around 12:00 on 22 November and GAC C reaching around 95% full by approximately 15:00 on 22 November and staying near that level until washing around 09:30 on 23 November. The level of GAC B also rose quickly from approximately 10:00 on 23 November (correlating with the wash of GAC C), reaching 96% full by 22:00 on 24 November. All three GAC vessels were above 95% full by 08:00 on 25 November, indicating they were all substantially blocked by this point and that the normal washing process was unable to rectify the situation.

Figure 8: Pembury GAC levels, approximately November 21-28 2025

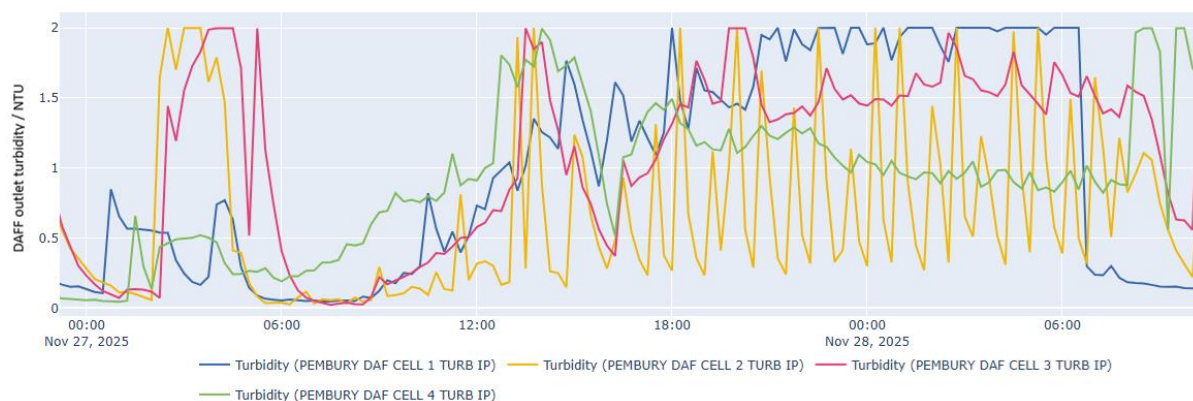
3.6.7 Throughout most of 27 November, the output of Pembury works was relatively stable compared to the previous day, with GAC outlet and pre-CT turbidities back to below 0.3 and 0.2 NTU, respectively. The DAFF turbidities however be seen to deteriorate and increase. The site was deliberately shut down between 15:00 and 16:00 to perform a more thorough cleaning of the PACI dosing injector, including a successful drop test to confirm coagulant dosing.

Figure 9: DAFF outlet turbidities worsening on 27 November 2025

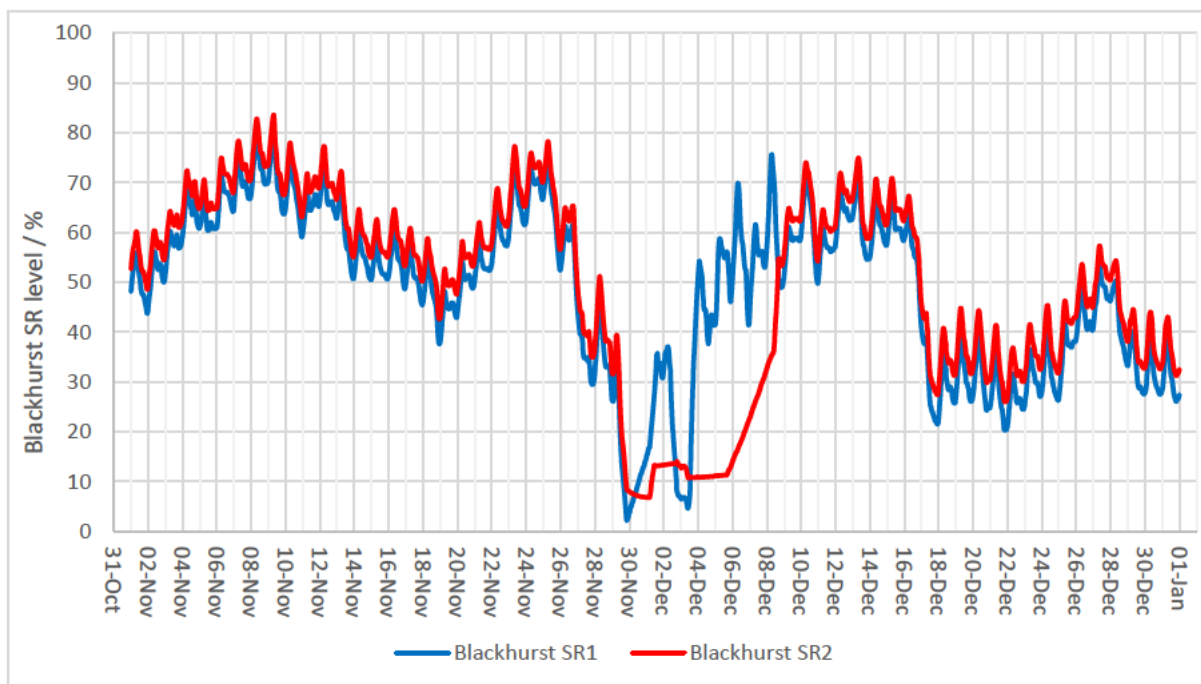
3.7.4 By 29 November, the repeated and ongoing outages/running to waste of Pembury works had significantly decreased the level of Blackhurst SR. Prior to 26 November and the first Pembury shutdown, the reservoir had been between approximately 70% full with the level varying throughout the rest of November between around 45 and 80%. By 10:00 on 29 November, both Blackhurst SR1 and SR2 were at 30% and dropping rapidly.

Figure 10: Levels in Blackhurst SR, 1 November - 31 December 2025

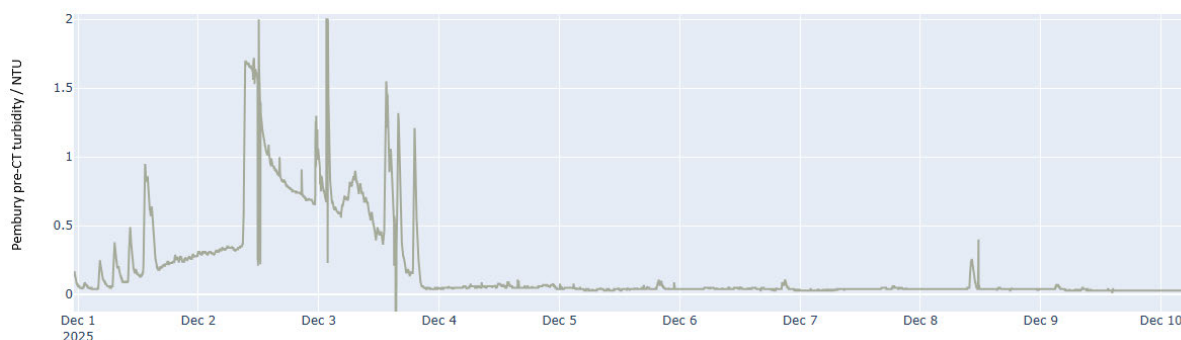
3.9.3 There were a series of turbidity spikes for pre-CT turbidity between around 13:00 and 19:00 on 3 December, all between 1 and 1.55 NTU at maximum with that maximum generally decreasing each time. These matched corresponding turbidity spikes from GAC A and C that appear related to washes and the washing of all four DAFF vessels. Ordinarily, these would have shut the site down before the limits was reached but with the revised triggers the site remained in supply. After the last pre-CT turbidity spike was over around 20:30, the pre-CT turbidity generally stayed below 0.1 NTU for around the next week, a significant change and improvement from the preceding days.

Figure 11: Improvement in pre-CT turbidity after 3 December 2025

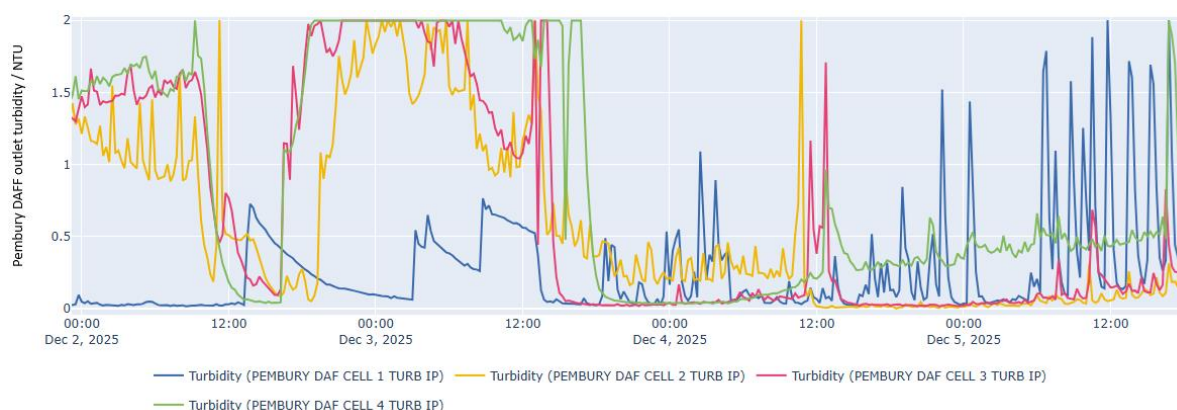
3.9.4 The combination of a new sulphated PACI coagulant, the revision of the pre-CT turbidity shutdown triggers (also allowing the site to shut down less often) and the revision of the site’s operating pH appear to have combined to allow Pembury works to significantly stabilise from around 19:15 on 3 December. Works flow also increased back to around 80 L/s. DAFF outlet turbidities appeared generally improved compared to the previous days; although still spiking, the baselines were much closer to 0 NTU as during normal operation. GAC vessels were also operating again at baseline turbidities with the level pattern also matching what is considered a more normal operation (Figure 12).

Figure 12: General improvements in DAFF turbidities after changes during 3 December 2025

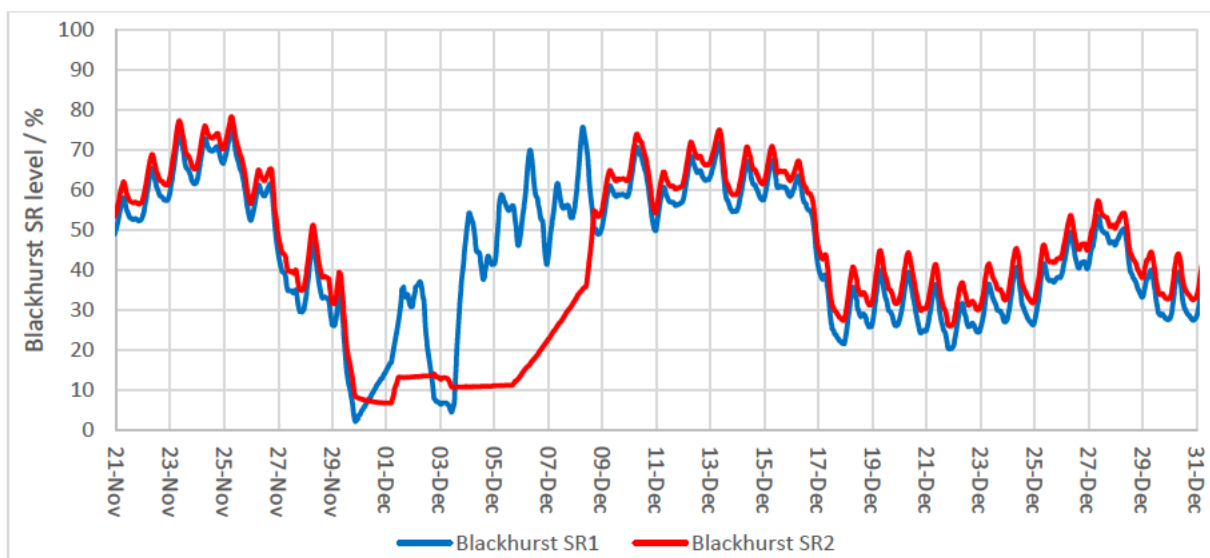
3.9.8 Around 06:30 on 5 December 2025, Pembury works (and the [REDACTED]) briefly shut down due to PACI bund alarm where the temporary hose connects. Later on 5 December, Blackhurst SR cell 2 was removed from isolation, refilling over the course of around three days to match Blackhurst SR Cell 1.

Figure 13: Blackhurst SR levels, 21 November to 31 December 2025
